**Flood Control Project Maintenance
Levee Inspections**
LMA District Cover Sheet
Spring 2019 Levee Inspection Results

Sacramento Maintenance Yard Putah Creek

Spring 2019 Levee Inspection Results

Levee Inspection Report By Mile - Spring 2019

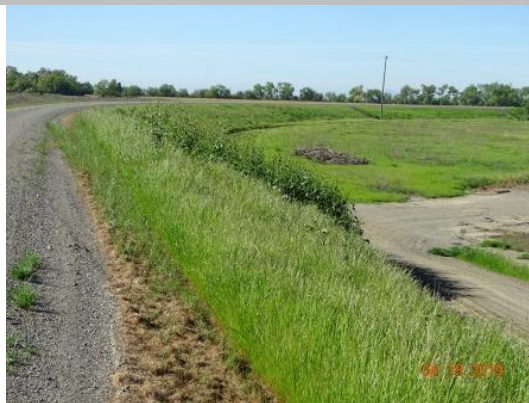
Photo 1 of 1 : SP_2019_ST0007_282_33_20190418_00069.jpg

LM Start	0.02	Rating **	M	Issue No.	33
LM End	6.78	Issue Type +	Ma	Location *	LS
Category	Earthen Levee			GPS Latitude/Longitude	
				Start	End
Item	Vegetation			38.523310 °	38.517630 °
				-121.631452 °	-121.749962 °
DWR ID	DWR_ST0007_01_s_2019_33				
Comment Code					
V1 : Control annual grass and weeds on the levee slopes and easements.					
Inspector Comment					
Maintain the annual vegetation.

View looking upstream at annual vegetation on the landside slope (Spring 2019).

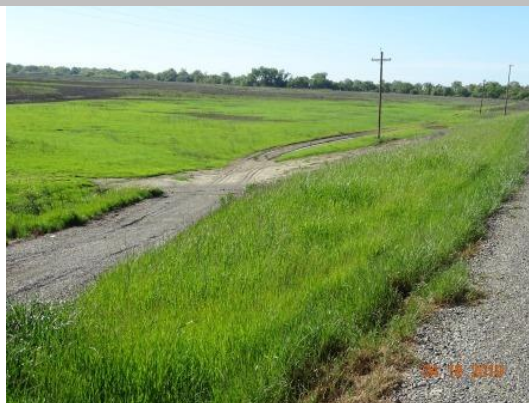
Photo 1 of 1 : SP_2019_ST0007_282_36_20190418_00068.jpg

LM Start	0.02	Rating **	U	Issue No.	36
LM End	4.82	Issue Type +	Ma	Location *	WS
Category	Earthen Levee			GPS Latitude/Longitude	
				Start	End
Item	Vegetation			38.523310 °	38.518031 °
				-121.631453 °	-121.713905 °
DWR ID	DWR_ST0007_01_s_2019_36				
Comment Code					
V1 : Control annual grass and weeds on the levee slopes and easements.					
Inspector Comment					
Maintain the annual vegetation.

View looking upstream at annual vegetation on the waterside slope (Spring 2019).

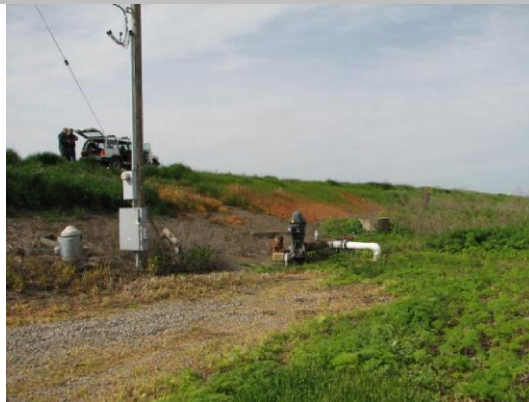
Photo 2 of 3 : UCIP_SP_2019_33408_60495.jpg

LS pump and appurtenances

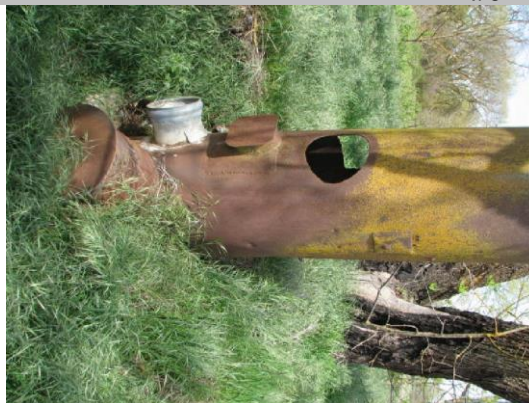
Photo 2 of 3 : UCIP_SP_2019_48013_60448.jpg

Steel Standpipe at 10-inch pipe termination 500-feet south of levee

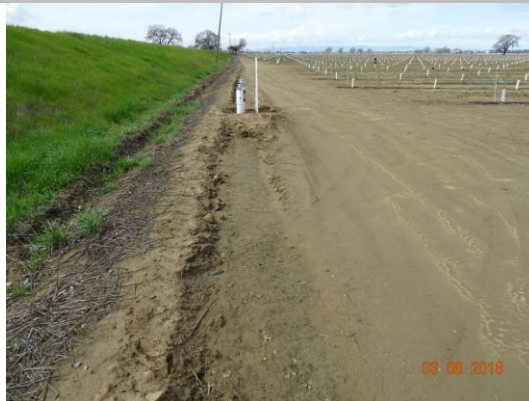
Photo 2 of 2 : SP_2019_ST0007_282_39_20190311_00010.jpg

LM Start	4.32	Rating **	M	Issue No.	39 (cont)
LM End	4.80	Issue Type +	En	Location *	LS
Category	Earthen Levee			GPS Latitude/Longitude	
				Start	End
Item	Encroachments			38.518280 °	38.518041 °
				-121.704657 °	-121.713680 °
DWR ID	DWR_ST0007_01_s _ 2018_39				
Comment Code					
PI : Pipe					
Inspector Comment					
Newly planted orchard on LS appears to have installed a water pipe with visible risers parallel to levee approx 8 feet from toe. This pipe should be verified, and owner should contact CVFPB for direction.

Suspected trenchline for new pipeline running parallel to levee, 8 feet from toe.

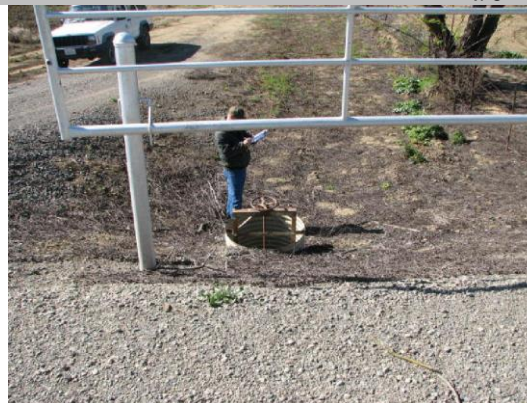
Photo 2 of 2 : UCIP_SP_2019_33370_60414.jpg

WS slide gate in 36-inch cmp standpipe

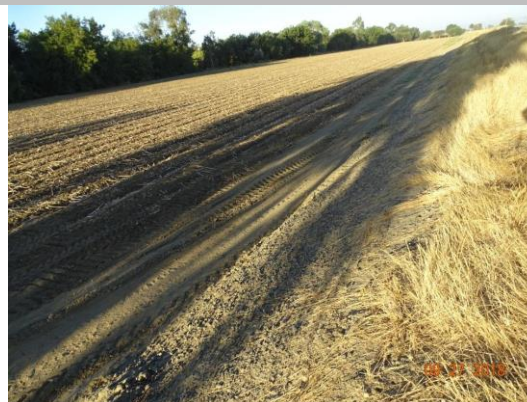
Photo 1 of 2 : SP_2019_ST0007_282_50_20190311_00011.jpg

LM Start	5.31	Rating **	A/W	Issue No.	50
LM End	5.39	Issue Type +	En	Location *	WS
Category	Earthen Levee			GPS Latitude/Longitude	
				Start	End
Item	Encroachments			38.518048 °	38.518132 °
				-121.723033 °	-121.724473 °
DWR ID	DWR_ST0007_01_f_2017_50				
Comment Code					
AT : Agricultural tilling					
Inspector Comment					
Access road now present where agricultural tilling was.

View looking upstream at the access road where the agricultural tilling was previously (September 2018).

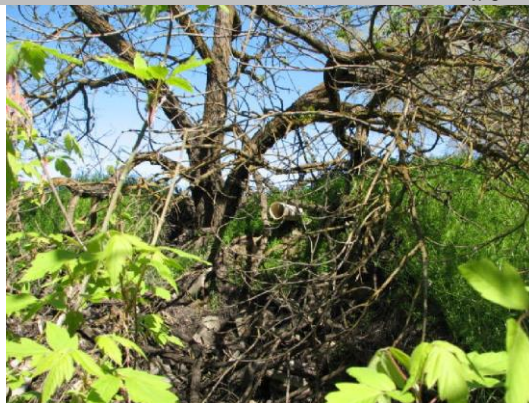
Photo 2 of 3 : UCIP_SP_2019_33367_60408.jpg

WS outfall at creek bank

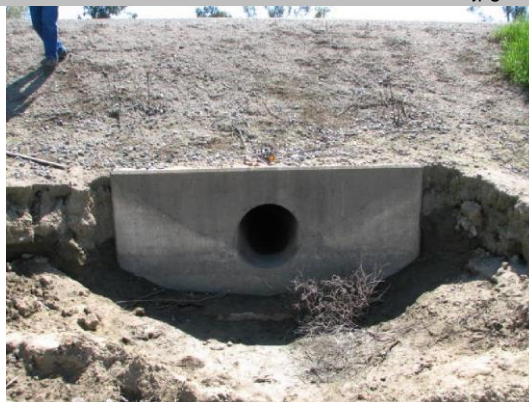
Photo 2 of 2 : UCIP_SP_2019_33349_60371.jpg

LS Headwall

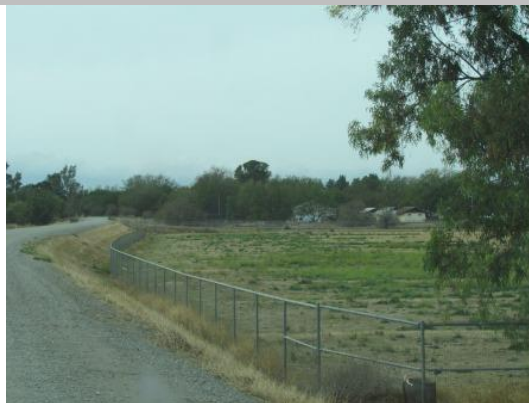
Photo 1 of 2 : SP_2019_ST0007_282_5_20190311_00002.jpg

LM Start	6.63	Rating **	M	Issue No.	5
LM End	6.71	Issue Type +	En	Location *	LS
Category	Earthen Levee			GPS Latitude/Longitude	
				Start	End
Item	Encroachments			38.517746°	38.517647°
				-121.747220°	-121.748679°
DWR ID	DWR_ST0007_01_s_2012_5				
Comment Code					
FE : Fence					
Inspector Comment					
A chainlink fence is located at the landside toe.

View of fence on landside within 10-foot of landward toe. Not a new encroachment.

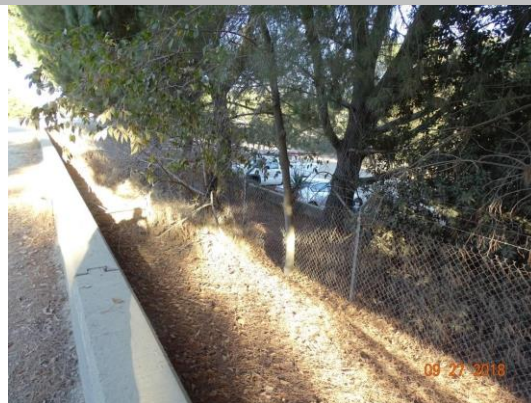
Photo 1 of 1 : SP_2019_ST0007_282_15_20190311_00005.jpg

LM Start	6.90	Rating **	M	Issue No.	15
LM End	6.96	Issue Type +	En	Location *	LS
Category	Earthen Levee			GPS Latitude/Longitude	
				Start	End
Item	Encroachments			38.517594 °	38.517709 °
				-121.752335 °	-121.753241 °
DWR ID	DWR_ST0007_01_s_2013_15				
Comment Code					
FE : Fence					
Inspector Comment					
This fence has no CVFPB Permit.

View of fence (September 2018).

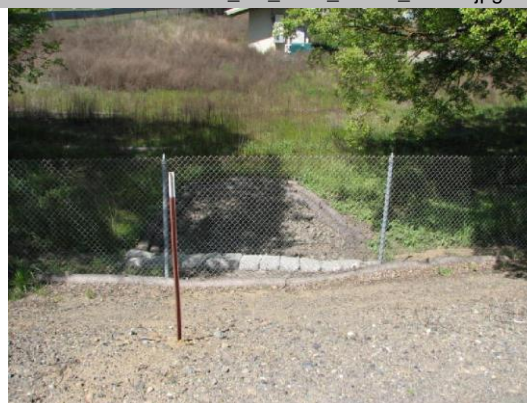
Photo 2 of 3 : UCIP_SP_2019_33343_60359.jpg

LS headwall

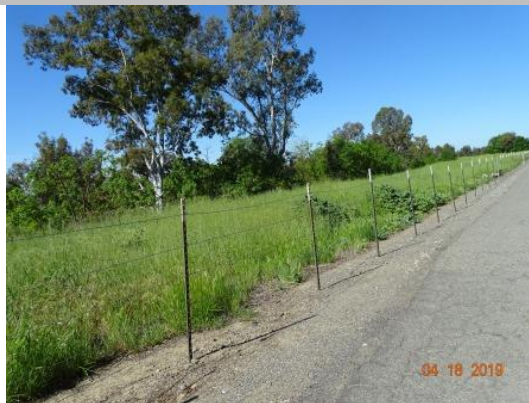
Photo 1 of 1 : SP_2019_ST0007_282_41_20190418_00072.jpg

LM Start	6.95	Rating **	M	Issue No.	41
LM End	7.18	Issue Type +	En	Location *	WS
Category	Earthen Levee			GPS Latitude/Longitude	
				Start	End
Item	Encroachments			38.517651 °	38.518178 °
				-121.753195 °	-121.757311 °
DWR ID	DWR_ST0007_01_s_2019_41				
Comment Code					
FE : Fence					
Inspector Comment					
There is a barbed wire fence on waterside shoulder.

View looking upstream at barbed wire fence on waterside shoulder (Spring 2019).

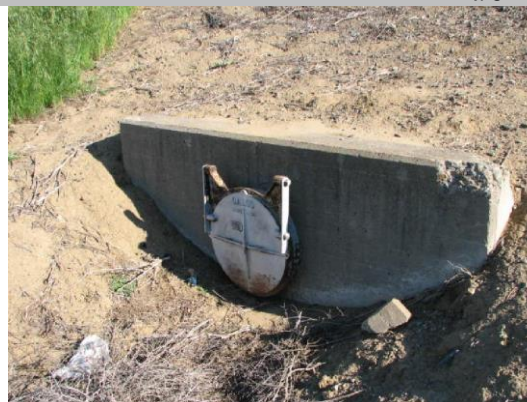
Photo 1 of 2 : UCIP_SP_2019_41353_60345.jpg

Comment Code						
Inspector Comment						
FS_ID:41353 DS_ID:516 EP_NO: 10260 Repair Type: Non-Urgent Crossing Status: Found UCIP Comments: Pipe is partially obstructed with sedimentation. Owner of pipe may have to clean sediment FIELD_STRUCT_DESC: 24-inch corrugated metal drainage pipe through the levee, 12 feet below the crown. Flap gate on the waterside (WS) end. (24-inch pipe [HLM 7.52] authorized under Automatic Board Order (ABO) issued as Permit No. 10260, 1974 - Southern Pacific Transportation Company). [Additional Reference(s): DWR Levee Log, 2005. USACE Sacramento O&M Manual 119, December 1952, (Station 193+20 PCT)]. FS Date: 4/10/2014 2:25:00 PM

WS Flap Gate and headwall.

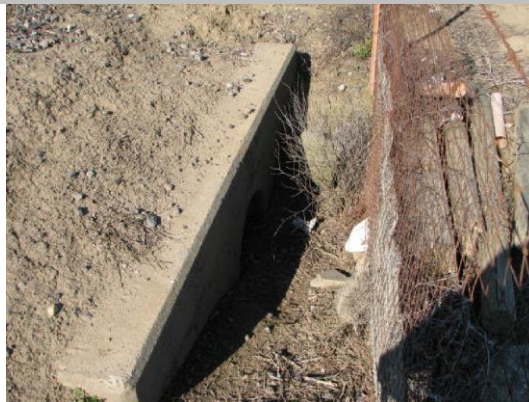
Photo 2 of 2 : UCIP_SP_2019_33333_60341.jpg

LS headwall showing fence and soil buildup.

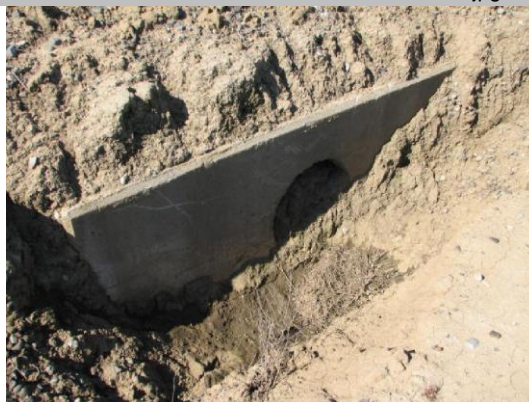
Photo 2 of 3 : UCIP_SP_2019_33328_60327.jpg

LS headwall showing pipe plugged with soil

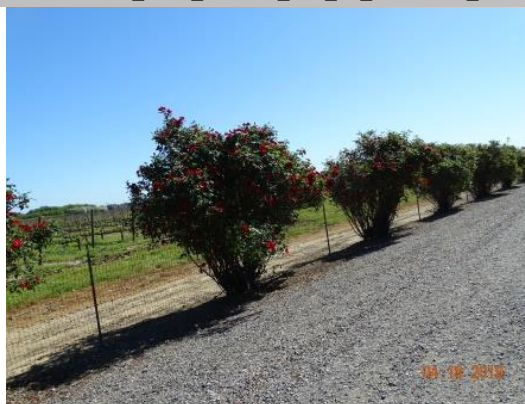
Photo 1 of 1 : SP_2019_ST0007_282_38_20190418_00073.jpg

LM Start	8.32	Rating **	M	Issue No.	38
LM End	8.62	Issue Type +	En	Location *	LS
Category	Earthen Levee			GPS Latitude/Longitude	
				Start	End
Item	Encroachments			38.521613 °	38.523854 °
				-121.777127 °	-121.781915 °
DWR ID	DWR_ST0007_01_s_2019_38				
Comment Code					
FE : Fence					
Inspector Comment					
There is a barbed wire fence on the landside.

View looking downstream at barbed wire fence on the landside easment (Spring 2019).

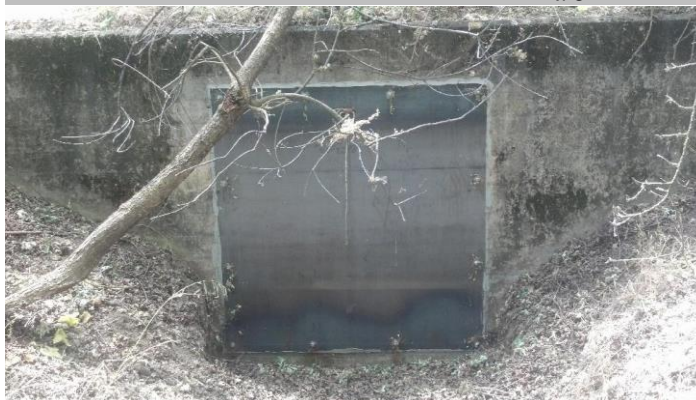
Photo 1 of 3 : UCIP_SP_2019_41129_60301.jpg

Steel plate installed over pipe off LS toe.

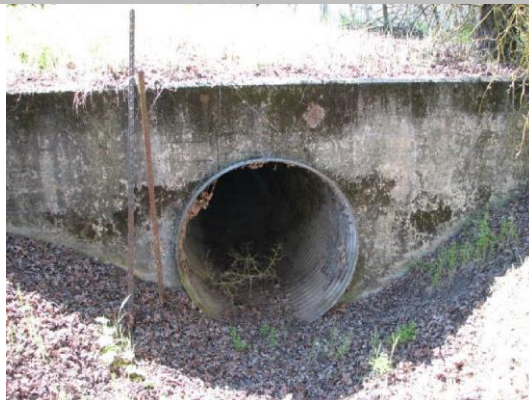
Photo 2 of 3 : UCIP_SP_2019_41129_60299.jpg

LS headwall and pipe before steel plate was installed over pipe to abandon it.

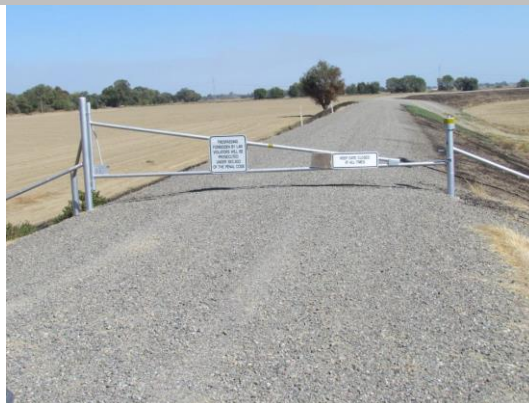
Photo 1 of 4 : SP_2019_ST0007_283_29_20190311_00006.jpg

LM Start	0.55	Rating **	M	Issue No.	29
LM End	0.55	Issue Type +	En	Location *	LS
Category	Earthen Levee			GPS Latitude/Longitude	
				Start	End
Item	Encroachments			38.510249 °	38.510249 °
				-121.667551 °	-121.667551 °
DWR ID	DWR_ST0007_02_s_2013_29				
Comment Code					
FE : Fence					
Inspector Comment					
There is no CVFPB Permit for this gate. DWR - Sac Maintenance Yard installed this gate a few years ago.

Levee mile 0.55 crown roadway crossing.

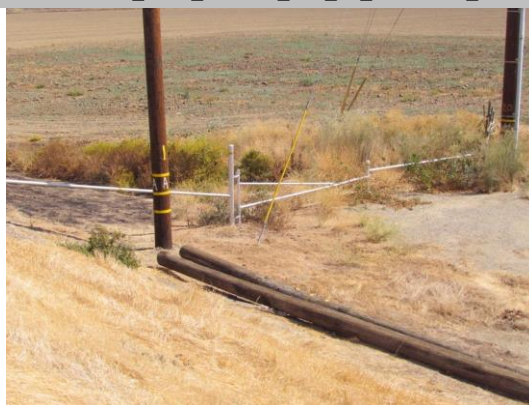
Photo 2 of 4 : SP_2019_ST0007_283_29_20190311_00007.jpg

View of landside slope and toe.

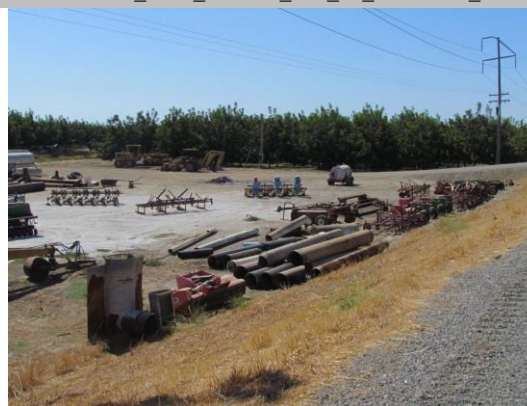
Photo 1 of 1 : SP_2019_ST0007_283_23_20190311_00004.jpg

LM Start	1.01	Rating **	M	Issue No.	23
LM End	1.05	Issue Type +	En	Location *	LS
Category	Earthen Levee			GPS Latitude/Longitude	
				Start	End
Item	Encroachments			38.511402 °	38.511598 °
				-121.675727 °	-121.676413 °
DWR ID	DWR_ST0007_02_f_2016_23				
Comment Code					
EQ : Equipment					
Inspector Comment					
This ag equipment and materials should be moved at least 10 feet away from the LS levee toe.

Levee mile 1.01 landside toe looking upstream.

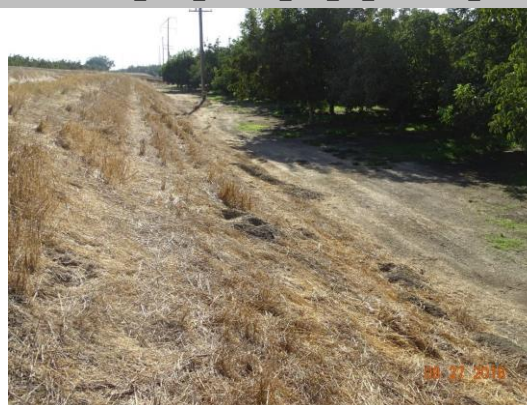
Photo 1 of 3 : SP_2019_ST0007_283_32_20190311_00010.jpg

LM Start	1.15	Rating **	U	Issue No.	32
LM End	1.15	Issue Type +	Ma	Location *	LS
Category	Earthen Levee			GPS Latitude/Longitude	
				Start	End
Item	Animal Control			38.512052 °	38.512052 °
				-121.678188 °	-121.678188 °
DWR ID	DWR_ST0007_02_f_2018_32				
Comment Code					
A1 : Exterminate rodents and backfill and compact or grout burrows.					
Inspector Comment					
There are multiple burrow holes with lots of fresh dirt outside several of the holes.

View looking downstream at multiple animal holes on the levee slope (September 2018).

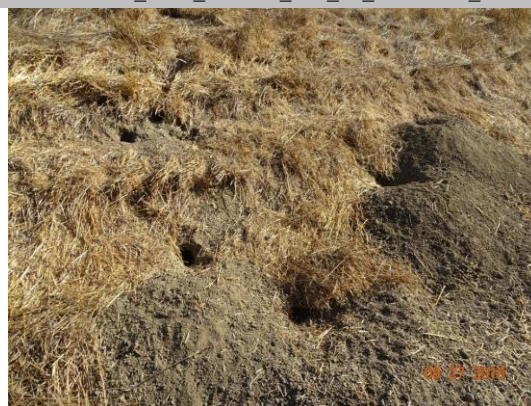
Photo 3 of 3 : SP_2019_ST0007_283_32_20190311_00012.jpg

LM Start	1.15	Rating **	U	Issue No.	32 (cont)	
LM End	1.15	Issue Type +	Ma	Location *	LS	
Category	Earthen Levee			GPS Latitude/Longitude		
				Start		End
Item	Animal Control			38.512052 °		38.512052 °
				-121.678188 °		-121.678188 °
DWR ID	DWR_ST0007_02_f_2018_32					
Comment Code						
A1 : Exterminate rodents and backfill and compact or grout burrows.						
Inspector Comment						
There are multiple burrow holes with lots of fresh dirt outside several of the holes.

View of multiple animal holes on the levee slope with fresh dirt in front of the holes (September 2018).

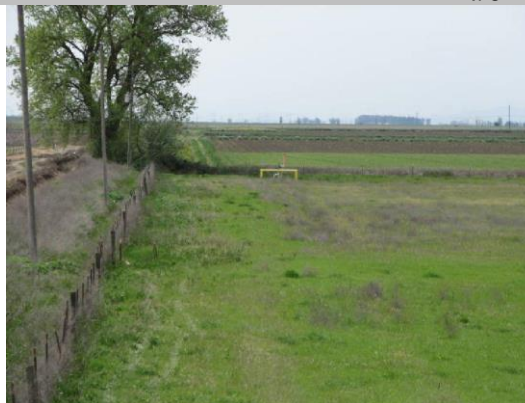
Photo 1 of 3 : UCIP_SP_2019_33400_60474.jpg

LM Start	1.60	Rating **	M	Issue No.	50
LM End	1.60	Issue Type +	En	Location *	
Category	Supplemental			GPS Latitude/Longitude	
				Start	End
Item	DWR UCIP Field Study			38.514250 °	38.514250 °
				-121.685980 °	-121.685980 °
DWR ID	16623				
Comment Code					
Inspector Comment					
FS_ID:33400 DS_ID:16623 EP_NO: 9139 Repair Type: Non-Urgent Crossing Status: Indicator Found UCIP Comments: There are no appropriate gas markers present on levee to indicate pipe location. Markers need to be installed. No danger to the levee FIELD_STRUCT_DESC: 8-inch steel gas line through the levee, 3 feet below the crown, under channel, and through the Unit No. 1 levee. (Permit No. 9139, 1973 - Dow Chemical, U.S.A.). [Additional Reference(s): DWR Levee Log, 2005]. FS Date: 4/10/2014 2:45:48 PM

Gas vent 800-feet to south

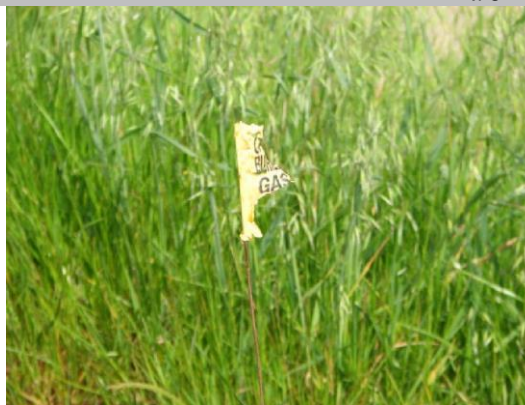
Photo 2 of 3 : UCIP_SP_2019_33400_60472.jpg

small flag on WS shoulder

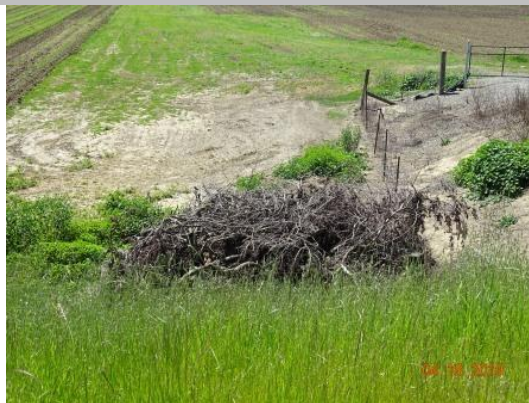
Photo 1 of 1 : SP_2019_ST0007_283_38_20190418_00064.jpg

LM Start	1.86	Rating **	U	Issue No.	38
LM End	1.86	Issue Type +	En	Location *	LS
Category	Earthen Levee			GPS Latitude/Longitude	
				Start	End
Item	Encroachments			38.515212 °	38.515212 °
				-121.690704 °	-121.690704 °
DWR ID	DWR_ST0007_02_s_2019_38				
Comment Code					
PR : Prunings					
Inspector Comment					
There is a large pruning pile on the landside.

View of large pruning pile at the landside toe (Spring 2019).

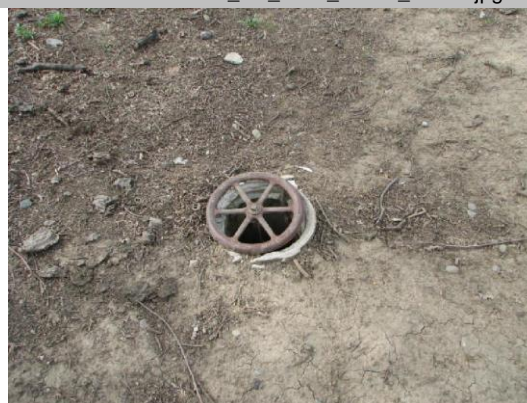
Photo 1 of 3 : UCIP_SP_2019_41072_60468.jpg

Comment Code					
Inspector Comment					
FS_ID:41072 DS_ID:16624 EP_NO: 10268 Repair Type: Non-Urgent Crossing Status: Found UCIP Comments: It is apparent that there is an irrigation pipe sleeved through the 25-inch pipe, but size cannot be determined. FIELD_STRUCT_DESC: 24-inch corrugated metal irrigation pipe through the levee, 13 feet below the crown. Gate valve on the landside (LS) in 10-inch concrete standpipe. 36-inch standpipe on the waterside (WS) toe. Headwall on the LS toe. (24-inch pipe authorized under Automatic Board Order (ABO) issued as Permit No. 10268, 1974 - Dow Chemical Company). [Additional Reference(s): DWR Levee Log, 2005. USACE Sacramento O&M Manual 119, December 1952, (Station P 265+70)]. FS Date: 4/10/2014 2:45:00 PM

gate valve on LS toe in 10-inch standpipe

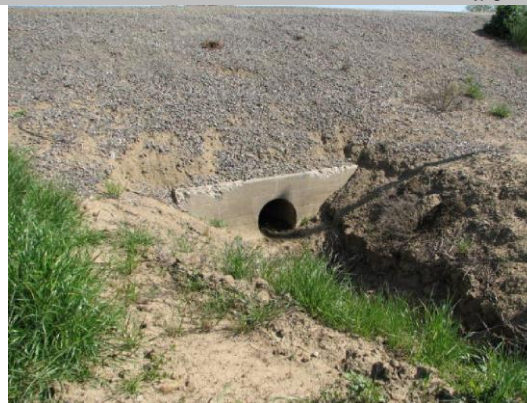
Photo 1 of 2 : UCIP_SP_2019_33378_60435.jpg

LM Start	4.17	Rating **	A/W	Issue No.	55
LM End	4.17	Issue Type +	Ma	Location *	
Category	Supplemental			GPS Latitude/Longitude	
				Start	End
Item	DWR UCIP LMA Responsibility			38.515770 °	38.515770 °
				-121.731840 °	-121.731840 °
DWR ID	16629				
Comment Code					
Inspector Comment					
FS_ID:33378 DS_ID:16629 EP_NO: 10269 Repair Type: No Action Needed Crossing Status: Found UCIP Comments: FIELD_STRUCT_DESC: 24-inch corrugated metal drainage pipe through the levee, 12.5 feet below the crown. Slide gate on the waterside (WS) end. Concrete headwalls on both ends. (24-inch pipe [HLM 4.26] authorized under Automatic Board Order (ABO) issued as Permit No. 10269, 1974 - Joseph Fahn). [Additional Reference(s): DWR Levee Log, 2005. USACE Sacramento O&M Manual 119, December 1952, (Station 109+75 PCT)]. FS Date: 4/10/2014 2:39:31 PM

LS headwall

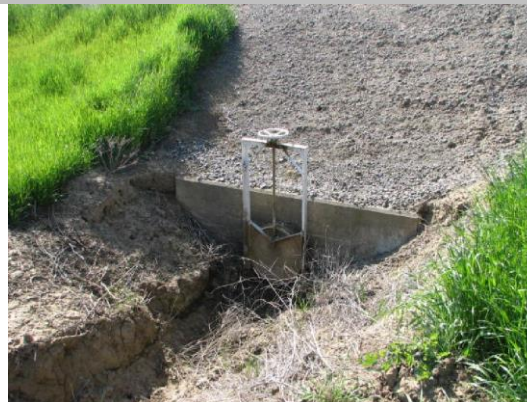
Photo 2 of 2 : UCIP_SP_2019_33378_60434.jpg

WS slide gate and headwall

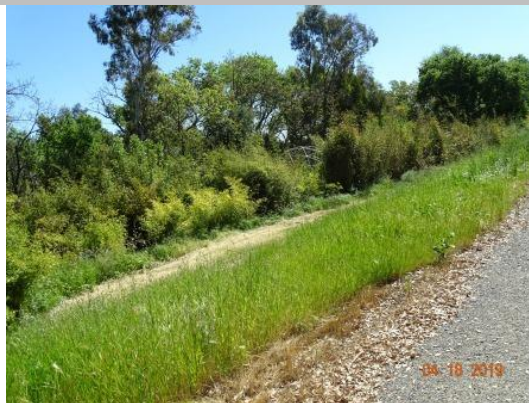
Photo 1 of 1 : SP_2019_ST0007_283_26_20190418_00059.jpg

LM Start	4.67	Rating **	M	Issue No.	26
LM End	7.08	Issue Type +	Ma	Location *	WS
Category	Earthen Levee			GPS Latitude/Longitude	
				Start	End
Item	Vegetation			38.515800 °	38.522679 °
				-121.741098 °	-121.782932 °
DWR ID	DWR_ST0007_02_s_2019_26				
Comment Code					
V1 : Control annual grass and weeds on the levee slopes and easements.					
Inspector Comment					
Maintain the annual vegetation.

View looking downstream at annual vegetation on the waterside slope (Spring 2019).

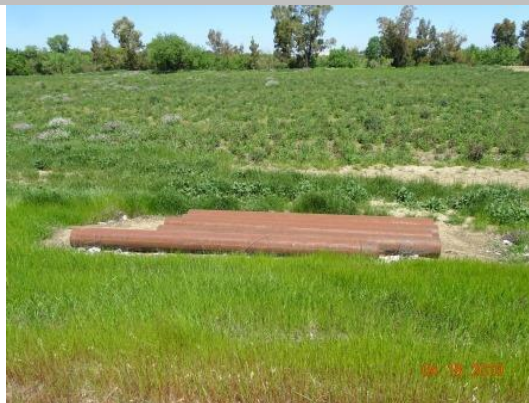
Photo 1 of 1 : SP_2019_ST0007_283_40_20190418_00065.jpg

LM Start	5.06	Rating **	M	Issue No.	40
LM End	5.06	Issue Type +	En	Location *	WS
Category	Earthen Levee			GPS Latitude/Longitude	
				Start	End
Item	Encroachments			38.515327 °	38.515327 °
				-121.748322 °	-121.748322 °
DWR ID	DWR_ST0007_02_s_2019_40				
Comment Code					
MA : Material					
Inspector Comment					
Several pipes need to be removed form slope.

View of pipes on the waterside slope (Spring 2019).

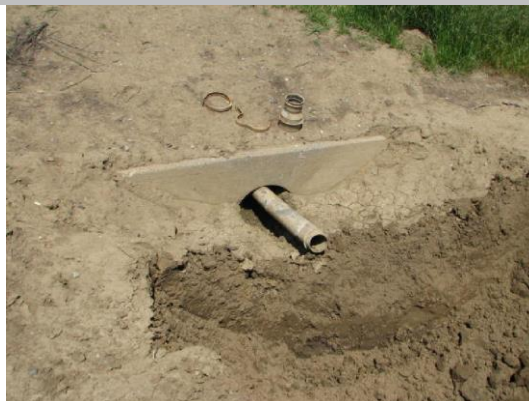
Photo 2 of 2 : UCIP_SP_2019_33363_60398.jpg

LS headwall showing sedimentation and 6-inch pipe sleeved through 24-inch pipe.

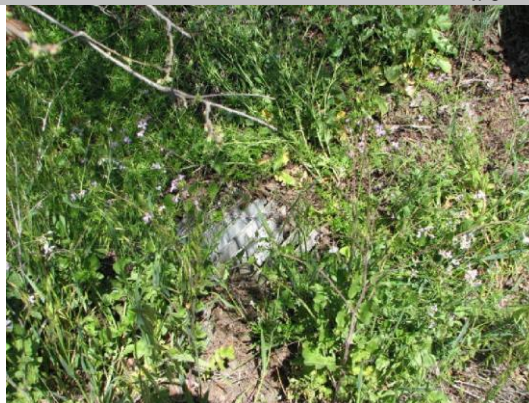
Photo 1 of 3 : UCIP_SP_2019_33348_60367.jpg

Dropinlet at LS toe.

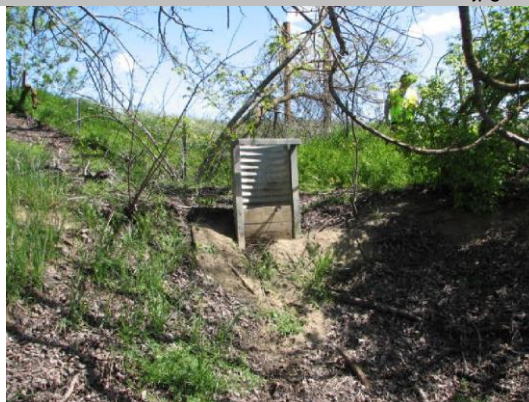
Photo 2 of 3 : UCIP_SP_2019_33348_60370.jpg

Weir inlet at pond on LS toe.

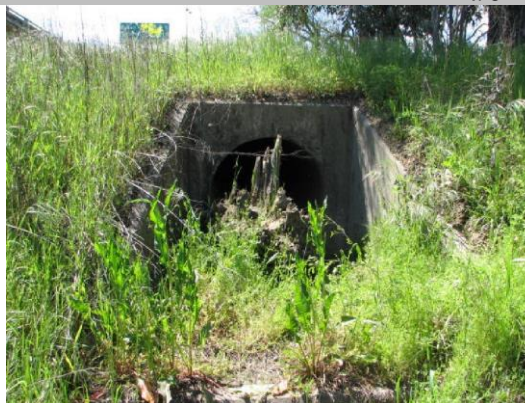
Photo 3 of 3 : UCIP_SP_2019_33348_60369.jpg

Comment Code						
Inspector Comment						
FS_ID:33348 DS_ID:16643 EP_NO: 7279 Repair Type: Non-Urgent Crossing Status: Found UCIP Comments: There is no handle on the slide gate operation mechanism and there is a large rootball blocking the outlet on WS. FIELD_STRUCT_DESC: 48-inch reinforced concrete drainage pipe through the levee, 26 feet below the crown. Slide gate in concrete box on the waterside (WS) slope of the levee. Drop inlet and weir inlet at the landside (LS) toe. Concrete headwall at outlet. Flap gate on the WS end is off. (Permit No. 7279, 1971 - State of California, Department of Public Works, Division of Highways and Bridges). [Additional Reference(s): DWR Levee Log, 2005]. FS Date: 4/10/2014 2:29:24 PM

WS headwall and outfall showing rootball blocking pipe

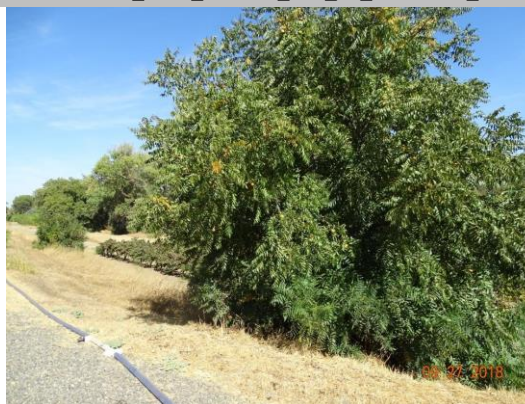
Photo 1 of 1 : SP_2019_ST0007_283_39_20190311_00016.jpg

LM Start	6.49	Rating **	U	Issue No.	39
LM End	6.49	Issue Type +	En	Location *	WS
Category	Earthen Levee			GPS Latitude/Longitude	
				Start	End
Item	Encroachments			38.518247 °	38.518247 °
				-121.773805 °	-121.773805 °
DWR ID	DWR_ST0007_02_f_2016_39				
Comment Code					
TR : Tree or limb					
Inspector Comment					
Three small walnut trees on the waterside shoulder should be removed.

View looking upstream of walnut trees on the waterside slope (September 2018).

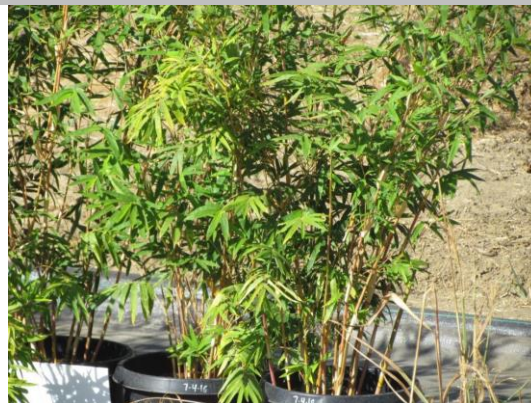
Photo 1 of 2 : SP_2019_ST0007_283_41_20190311_00017.jpg

LM Start	6.53	Rating **	U	Issue No.	41
LM End	6.71	Issue Type +	En	Location *	WS
Category	Earthen Levee			GPS Latitude/Longitude	
				Start	End
Item	Encroachments			38.518497 °	38.519953 °
				-121.774398 °	-121.777080 °
DWR ID	DWR_ST0007_02_s_2017_41				
Comment Code					
TR : Tree or limb					
Inspector Comment					
Bamboo being introduced by landowner on the waterside berm. This is unauthorized.

Unauthorized planting of arundo plants.

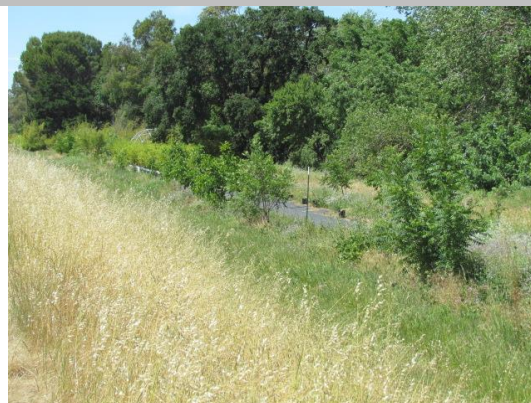
Photo 2 of 2 : SP_2019_ST0007_283_41_20190311_00018.jpg

Waterward berm landowner has several hundred bamboo plants and other crops on waterside.

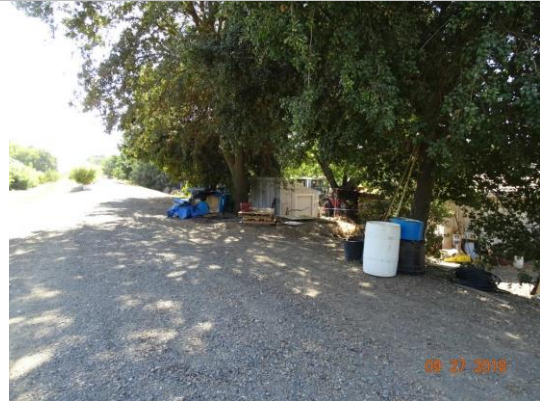
Photo 1 of 1 : SP_2019_ST0007_283_11_20190311_00003.jpg

LM Start	6.56	Rating **	M	Issue No.	11
LM End	6.70	Issue Type +	En	Location *	LS
Category	Earthen Levee			GPS Latitude/Longitude	
				Start	End
Item	Encroachments			38.518760 °	38.519938 °
				-121.774927 °	-121.776952 °
DWR ID	DWR_ST0007_02_s_2012_11				
Comment Code					
MA : Material					
Inspector Comment					
Shipping containers, storage units and other items/debris on the landside easement need to be moved.

View looking downstream at some of the debris on the landside slope almost up to the crown (September 2018).

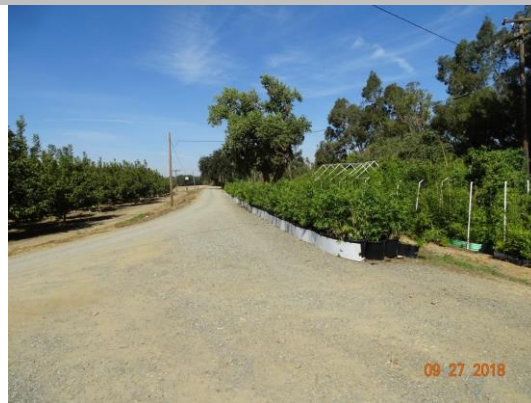
Photo 1 of 1 : SP_2019_ST0007_283_35_20190311_00015.jpg

LM Start	6.71	Rating **	U	Issue No.	35
LM End	6.74	Issue Type +	En	Location *	CR
Category	Earthen Levee			GPS Latitude/Longitude	
				Start	End
Item	Encroachments			38.519980 °	38.520198 °
				-121.777138 °	-121.777535 °
DWR ID	DWR_ST0007_02_f_2018_35				
Comment Code					
TR : Tree or limb					
Inspector Comment					
Remove bamboo pots from waterside crown.

View of bamboo in pots on the crown (September 2018).
